Manhole Inspection Summary

Manhole # S43CC_047MH

Insp Date: **12/19/07 10:14 AM**

Location Address: **1601 e.eager st**

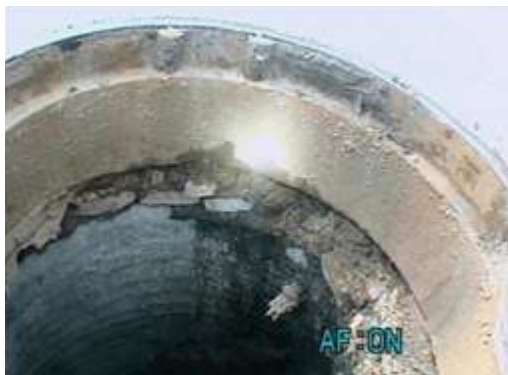
Defect 5

Condition: ☐ Sound ☐ Cracked ☐ Root Intrusion ☒ **Loose Brick** ☐ Deteriorated

loose bricks, frame adj

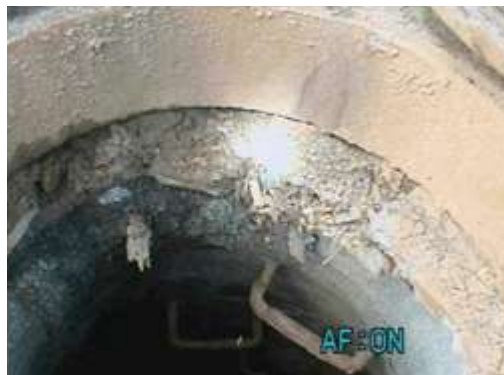
Defect 4

Offset: **4** (in.)

offset

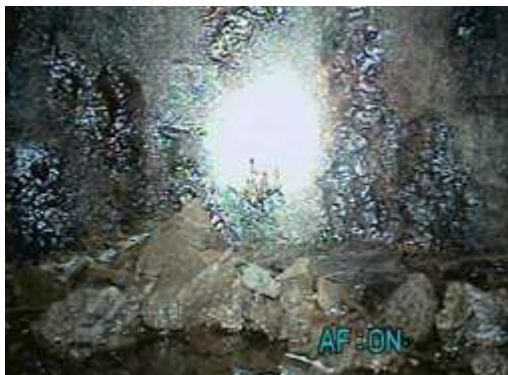
Defect 3

Condition: ☐ Sound ☐ Cracked ☐ Root Intrusion ☐ Deteriorated ☐ Leaks ☒ **Debris**

channel debris

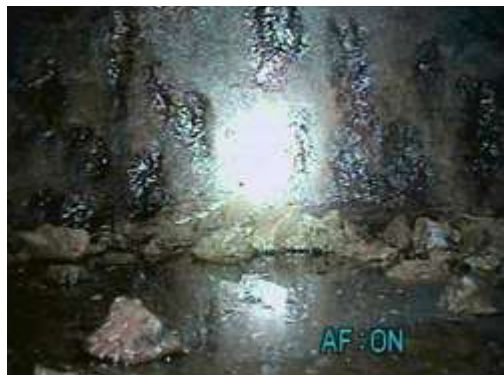
Defect 2

Infiltration: ☐ None ☐ Joint ☐ Cracks ☐ Mortar ☐ Roots ☒ **Wall**

infiltration in barrel wall

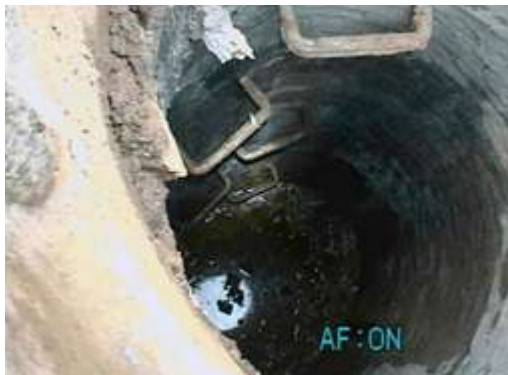
Defect 1

Count: **5** Missing: **1** ☒ **Corroded**

missing/corroded steps
